## Appendix A

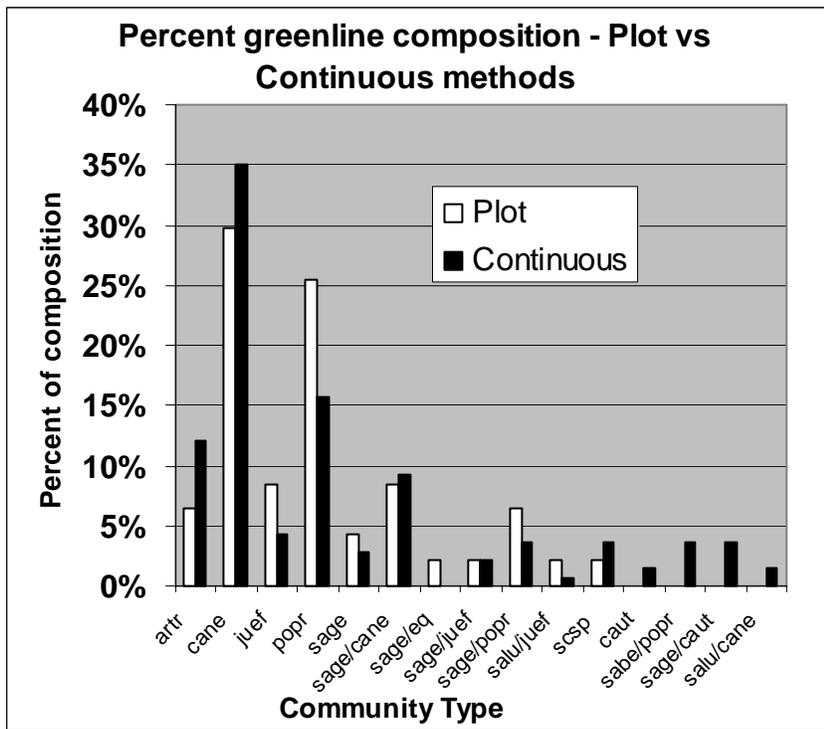
**Figure 1.** A comparison of estimates of dominant riparian vegetation community type composition along the greenline, using the plot method and the continuous measurement approach suggested by Winward (2000).

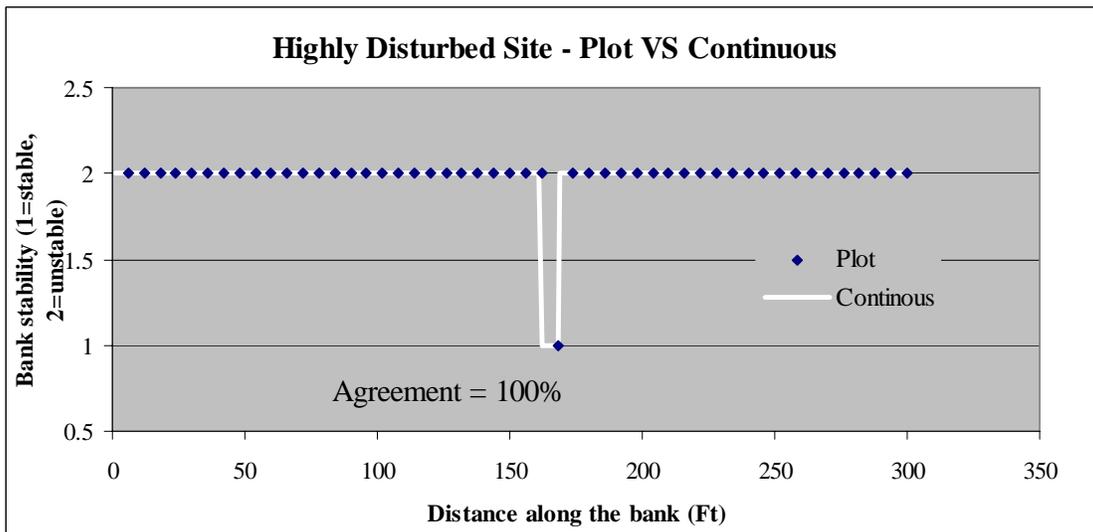
**Figure 2.** A comparison of streambank stability estimates along the greenline from plot and continuous observations in the highly disturbed (unstable) stream reach.

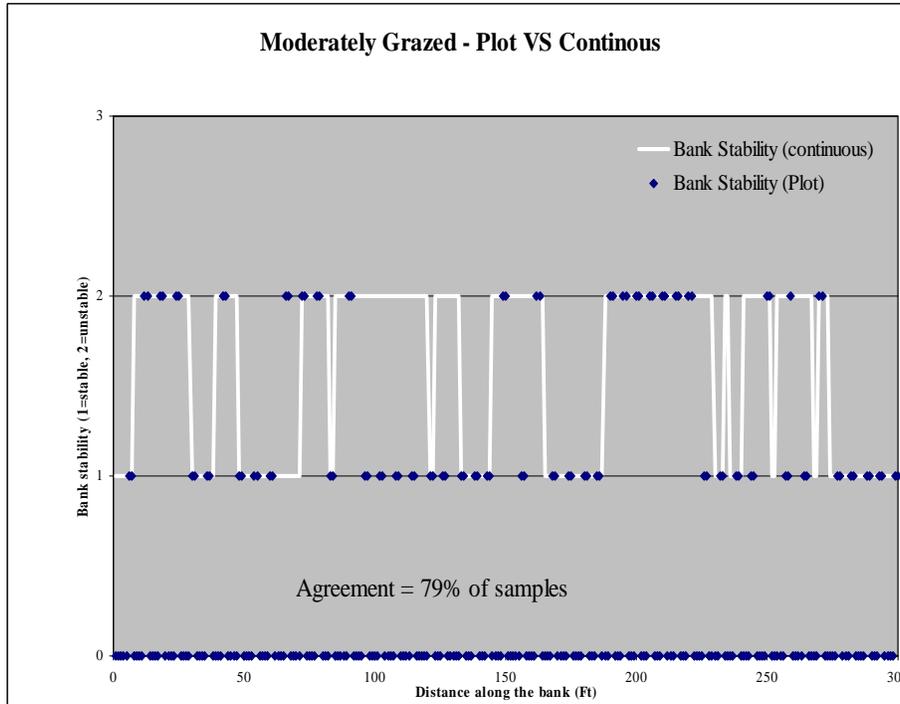
**Figure 3.** . A comparison of streambank stability estimates along the greenline from plot and continuous observations in the moderately grazed stream reach.

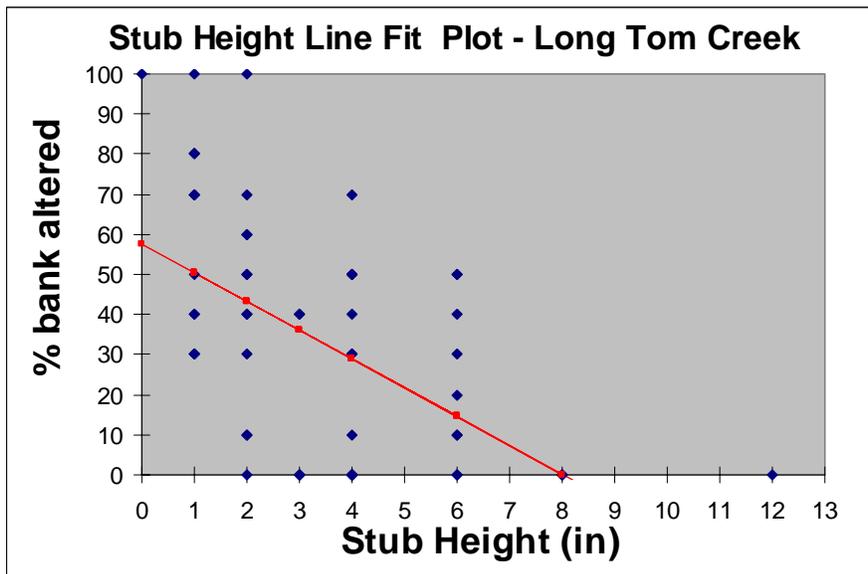
**Figure 4.** The relationship of stubble height to percent streambank altered using the plot method on Long Tom Creek.
