## APPENDIX E—Streambank Stability Examples

Examples in this appendix provide some streambank stability scenarios. They should be used jointly with Appendices A and B and the descriptions provided in body of the protocol.

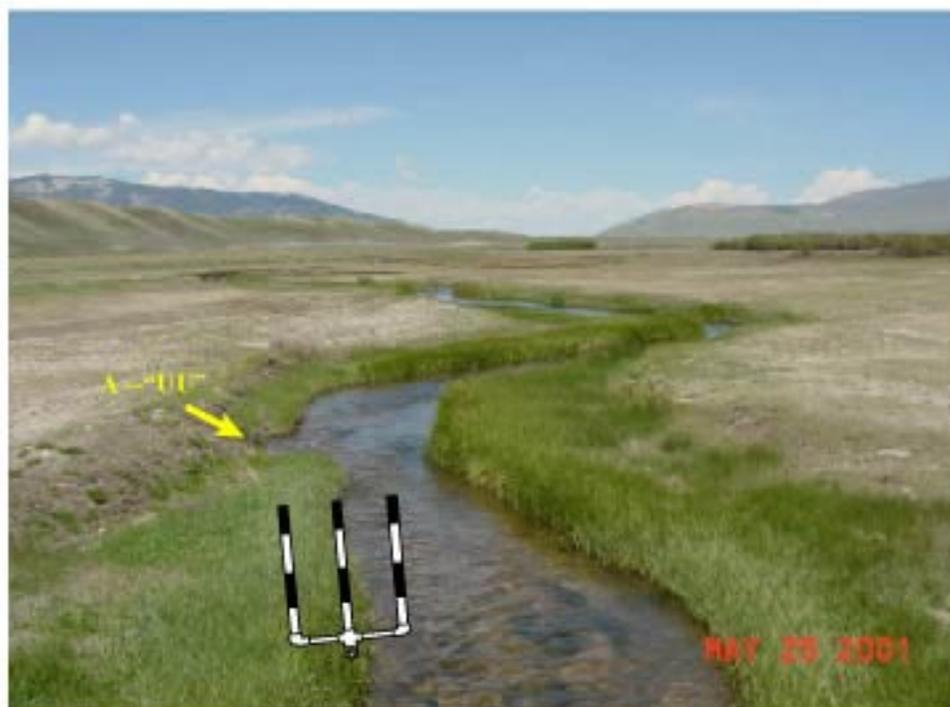
**Figure 1**-- Streambanks and floodplain covered with sedges and rushes, covered/stable, IIB 1a (1a). Note A is a small area of "uncovered/unstable" IIA 2a (2)(b)

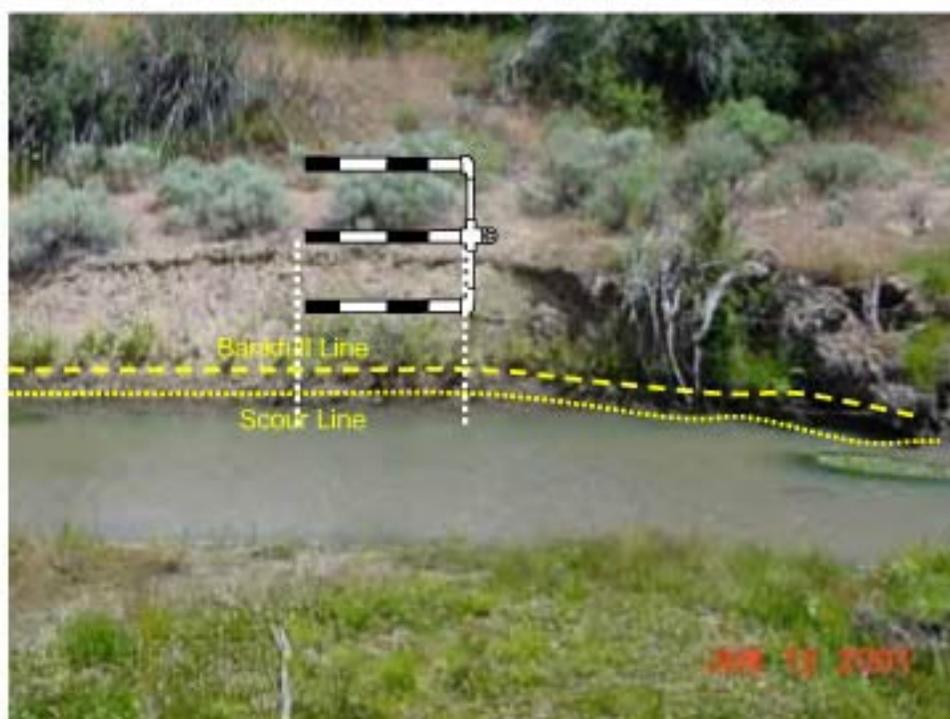
**Figure 2**—The scow line as at the base flow and the bankfull line is near the perennial vegetation line. This bank is classified as uncovered/unstable, IIB 1a (2a).

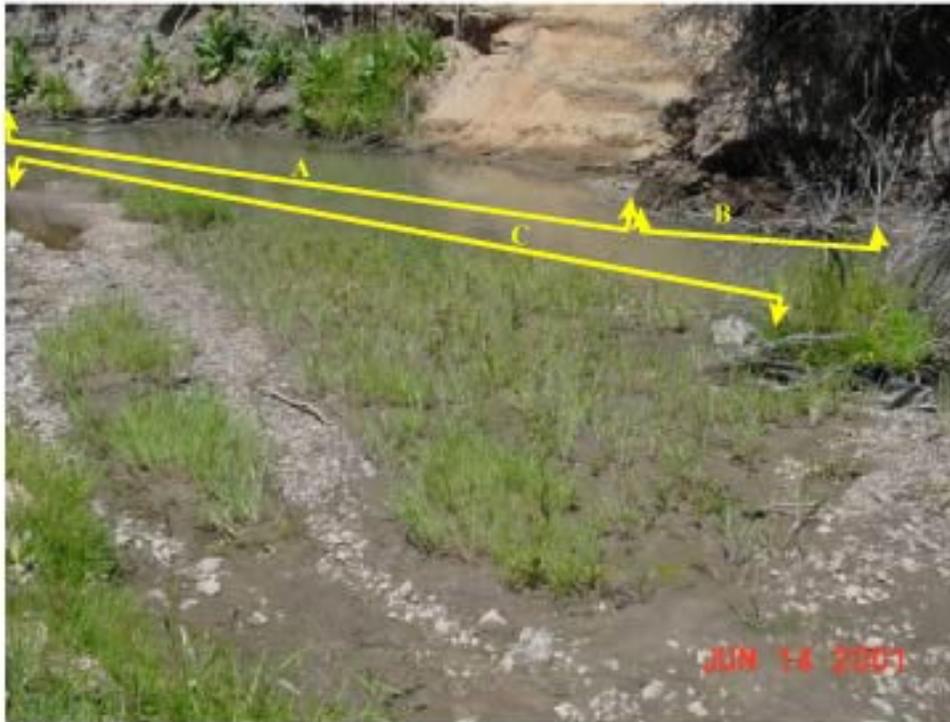
**Figure 3**—“A” is an erosional bank with little cover, uncovered/unstable (IIA 2a (2)(a)). “B” is an erosional bank composed of bedrock, covered/stable (IIA 2a (1)(a)). “C” is a depositional streambank with non-continuous, weak-rooted, perennial pioneering vegetation (*Alopecurus aqualis*, short-awned oxtail), uncovered/unstable (IIA 1a (2))

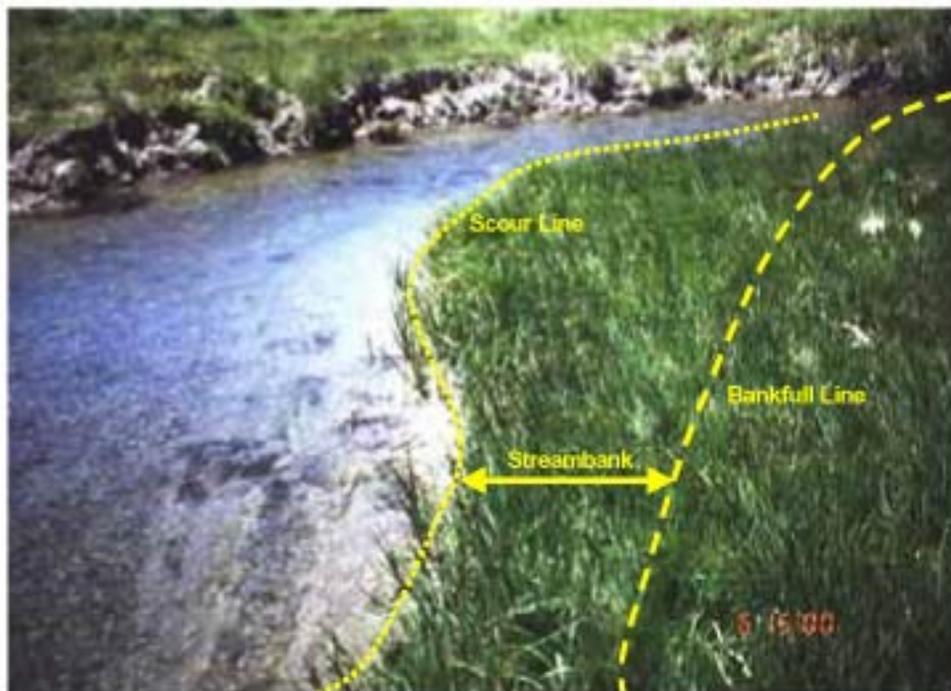
**Figure 4**—The streambank to be evaluated is between the scour line and the bankfull line. There a distinct change in the bank angle just below the bankfull line. This bank is covered/stable (CS), IIA 2a.

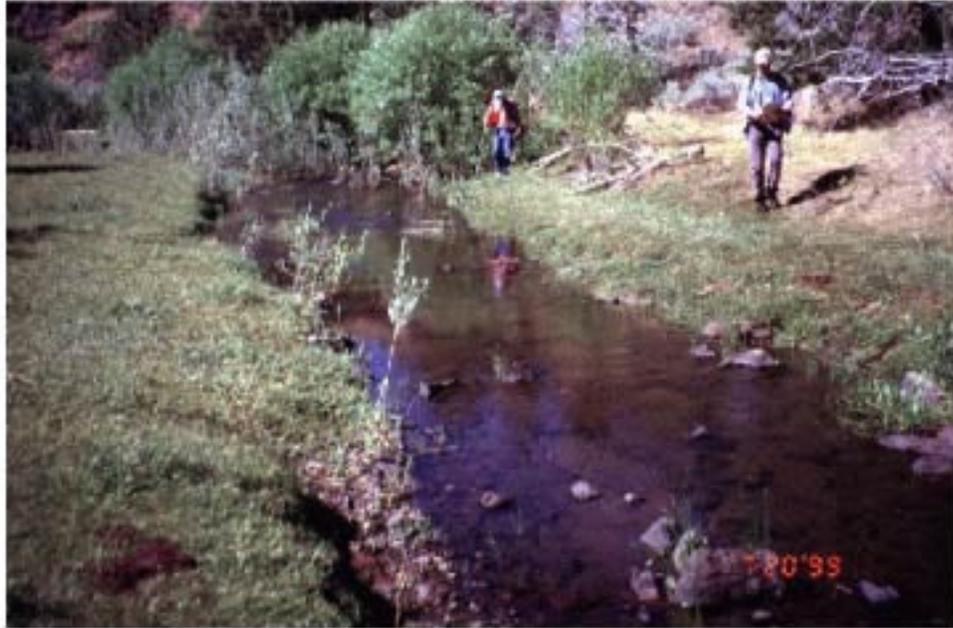
**Figure 5**--Streambanks covered with perennial sod-forming Kentucky bluegrass and low vigor Nebraska sedge and willows, covered/unstable (IIA 2a (1)(b)).

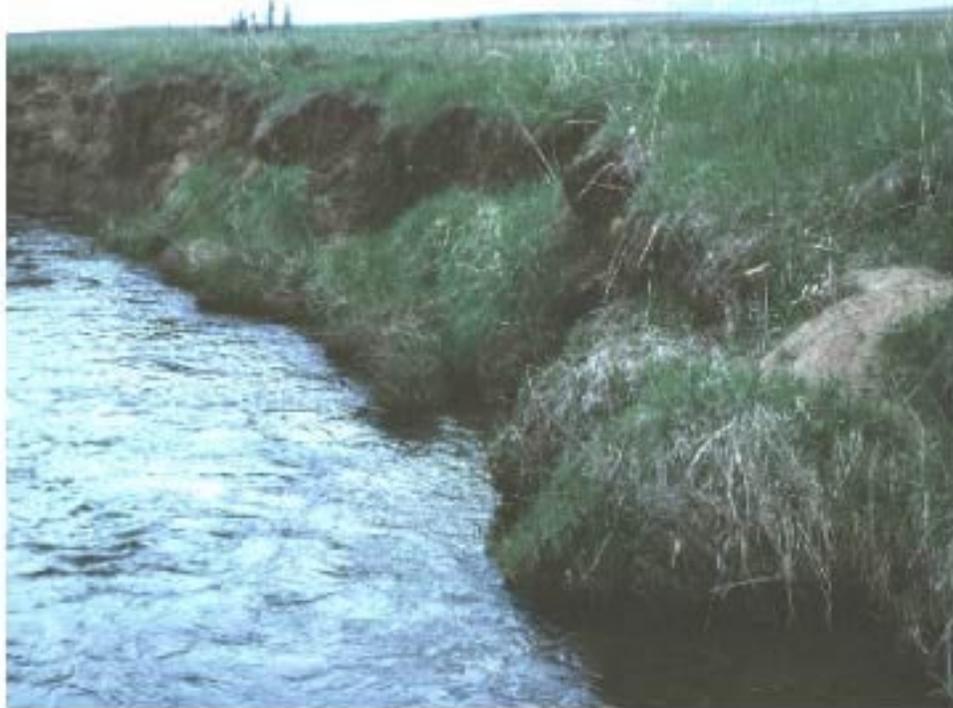
**Figure 6**--Slump blocks above the scour line. Vegetation on the blocks is upland and not considered deep-rooted. IIB 2b (2)

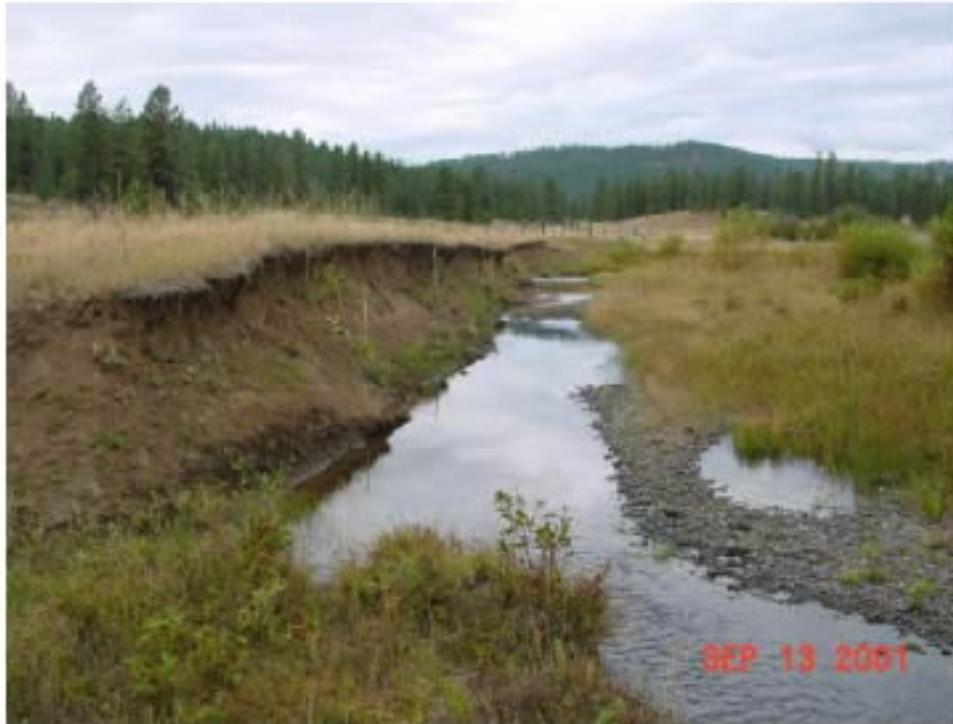
**Figure 7**–Left bank is not covered and the consolidated soil has resulted in a bank slope that is greater than 10 degrees from vertical, uncovered/stable ( IIA 2a (2)(b)). The right bank is covered with a continuous line of vigorous deep-rooted riparian vegetation, covered/stable (IIA 1b (a)).

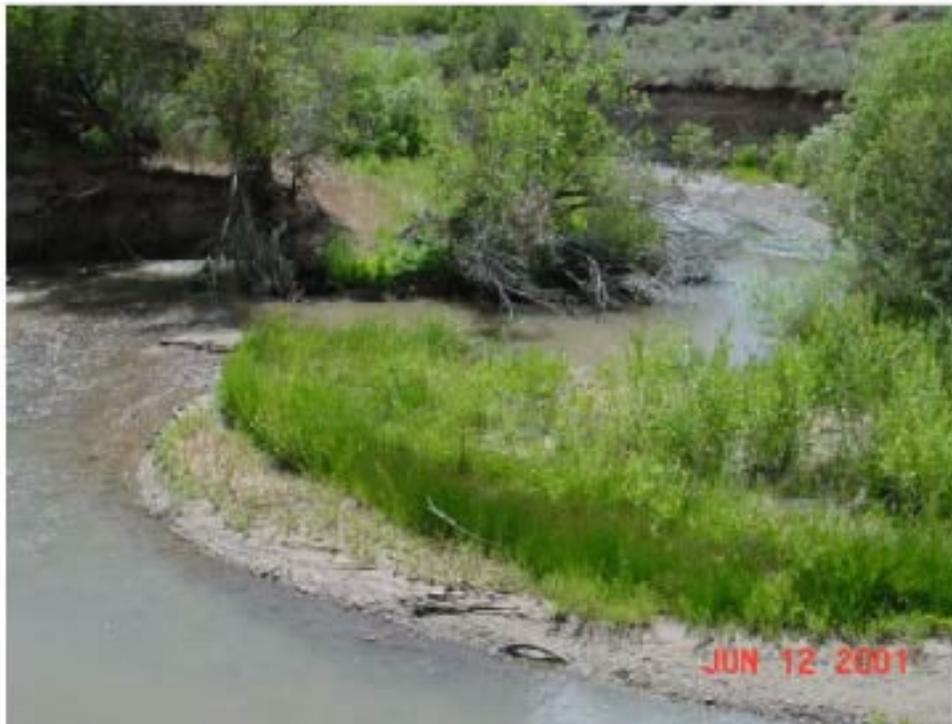
**Figure 8**–Point bar with continuous line of perennial deep-rooted vigorous vegetation at least one foot wide, covered/stable (IIB 1b (1)(a))

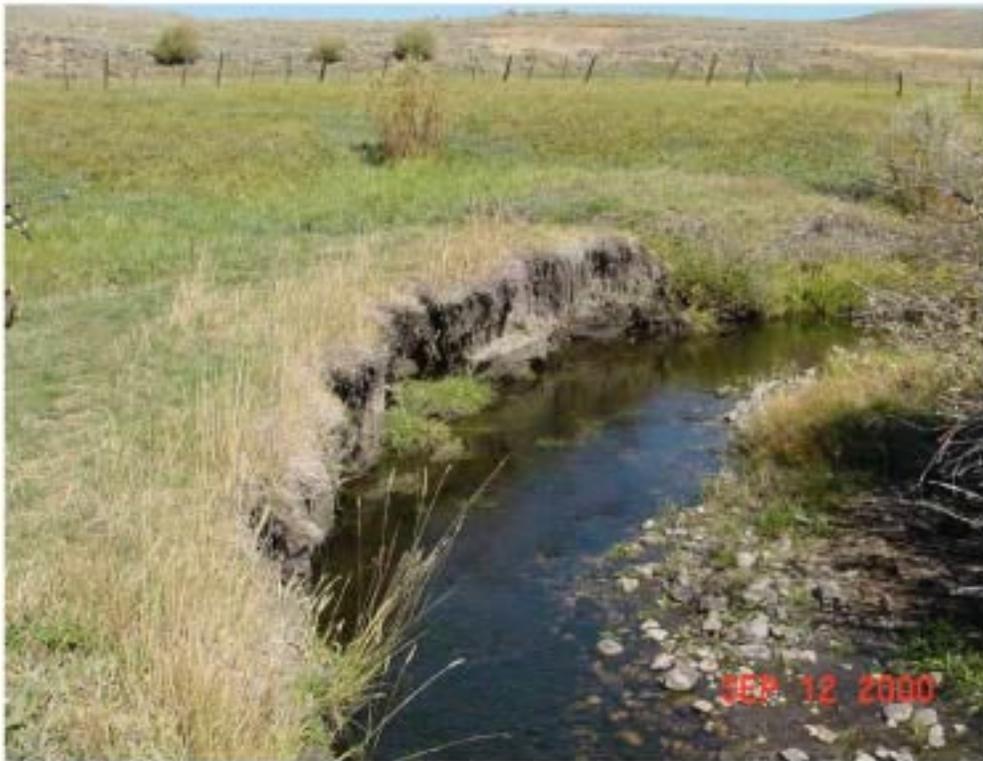
**Figure 9**—Slump block features below the scour line and not considered part of the streambank. Cracks or fractures are above the scour line, uncovered/unstable (IIA 2b (2)).

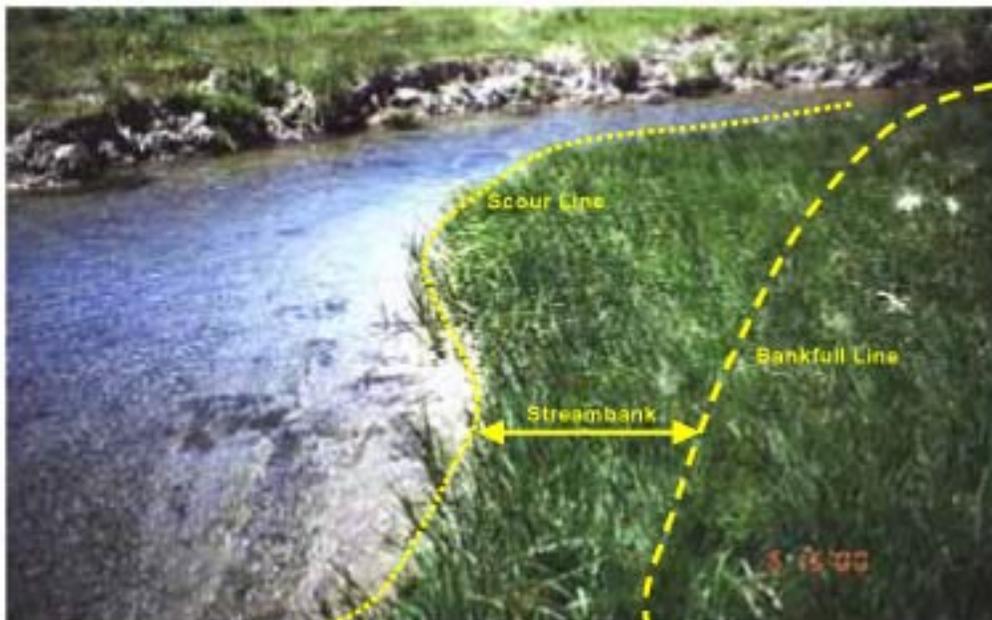
**Figure 10**—The streambank to be evaluated is between the scour line and the bankfull line. There a distinct change in the bank angle just below the bankfull line. This bank is covered/stable (CS), IIA 2a.

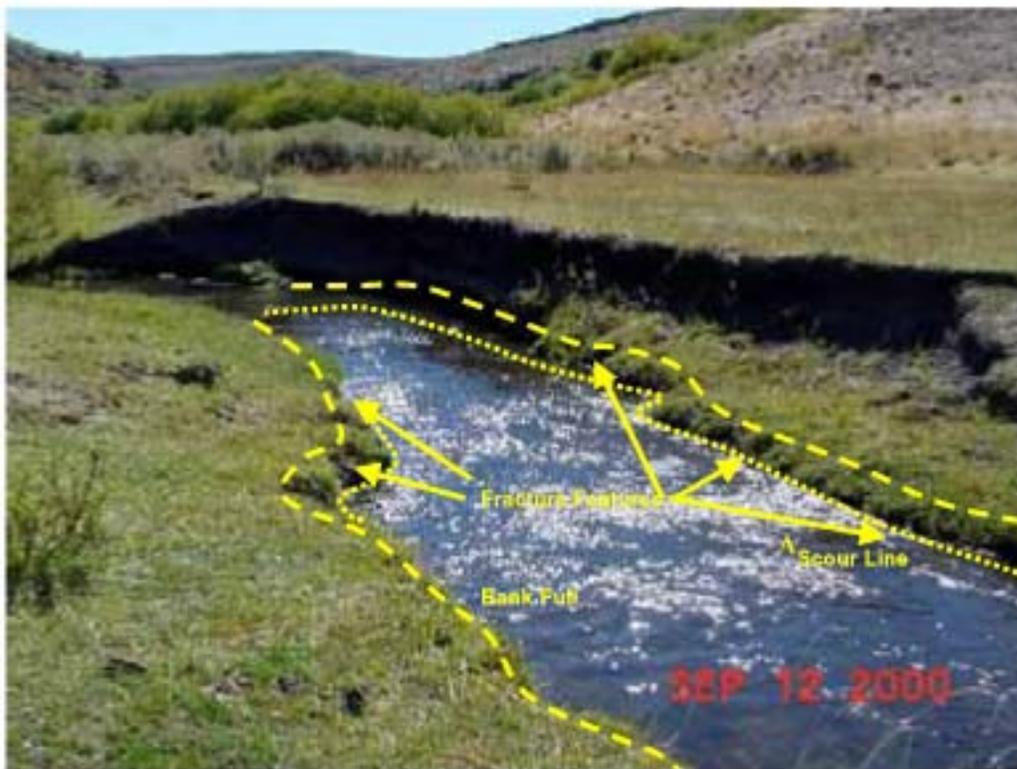
**Figure 11**—The scour line is at the base flow level. The streambank is between the scour line and the bankfull line. There are a number of fracture features along the stream. The streambank has fracture features with the slump blocks no longer attached. “A” is covered/unstable (CU), IIB 1a (1b).

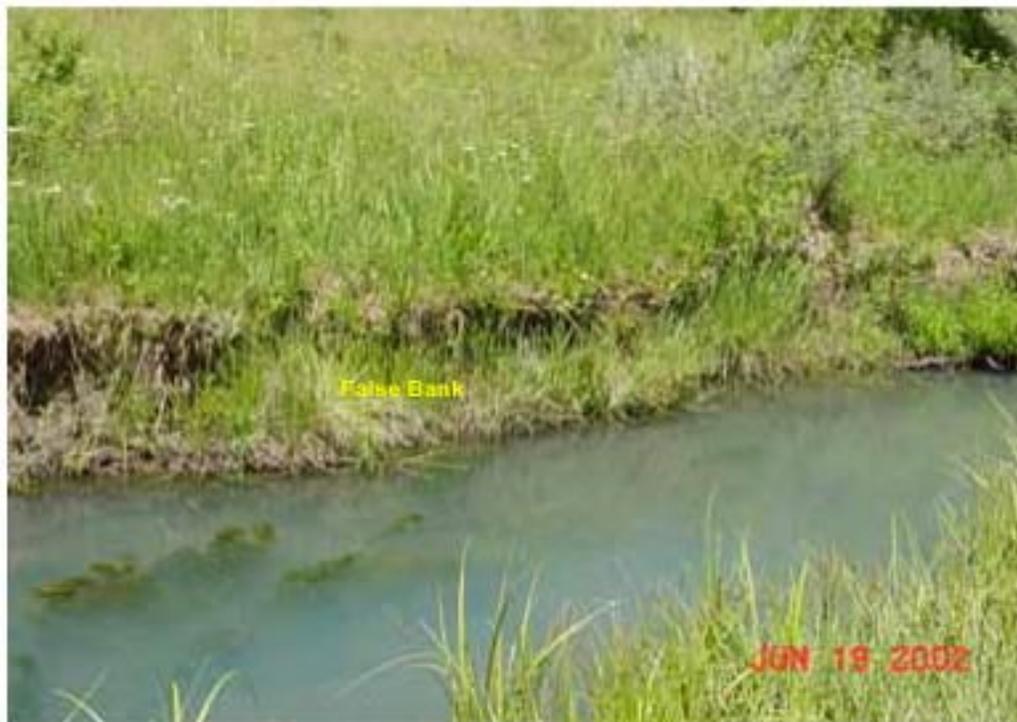
**Figure 12**—False bank is a slump block that is reattached and with vegetative cover.

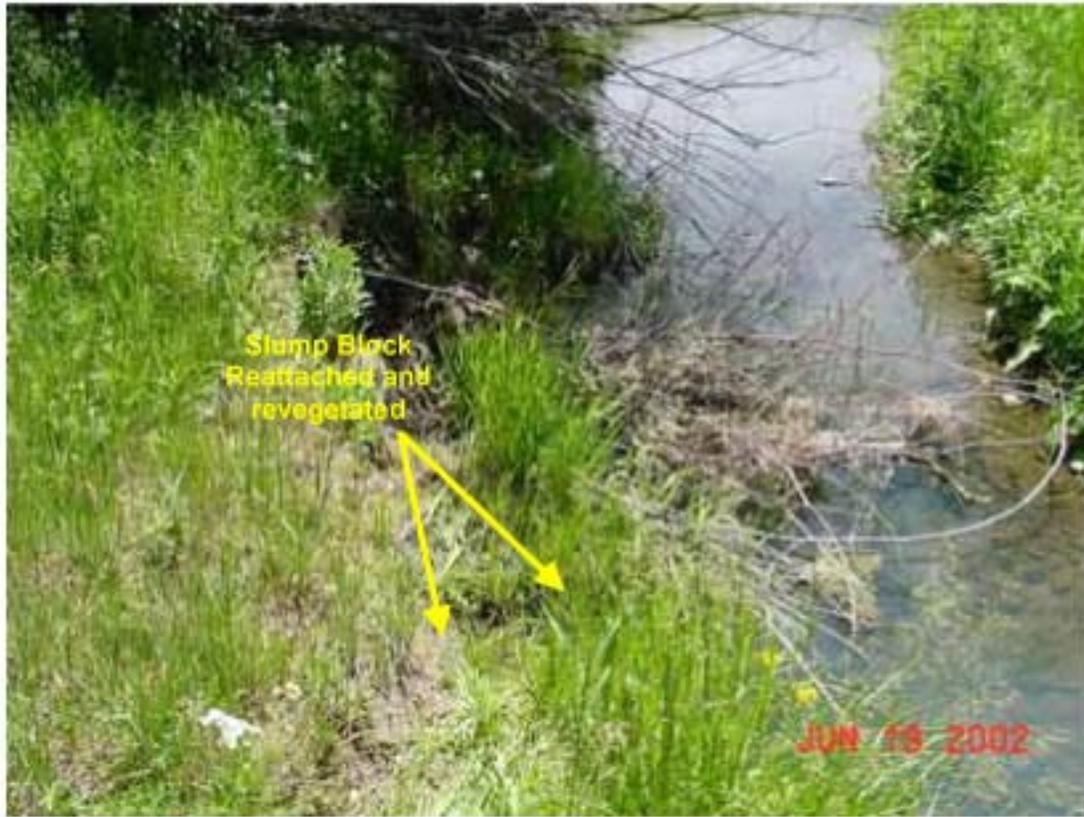
**Figure 13**—Slump block reattached and vegetated. It is classified as a false bank and is covered/stable CS.
