**APPENDIX F**  
**Streambank Alteration**

**Streambank Alteration Key**

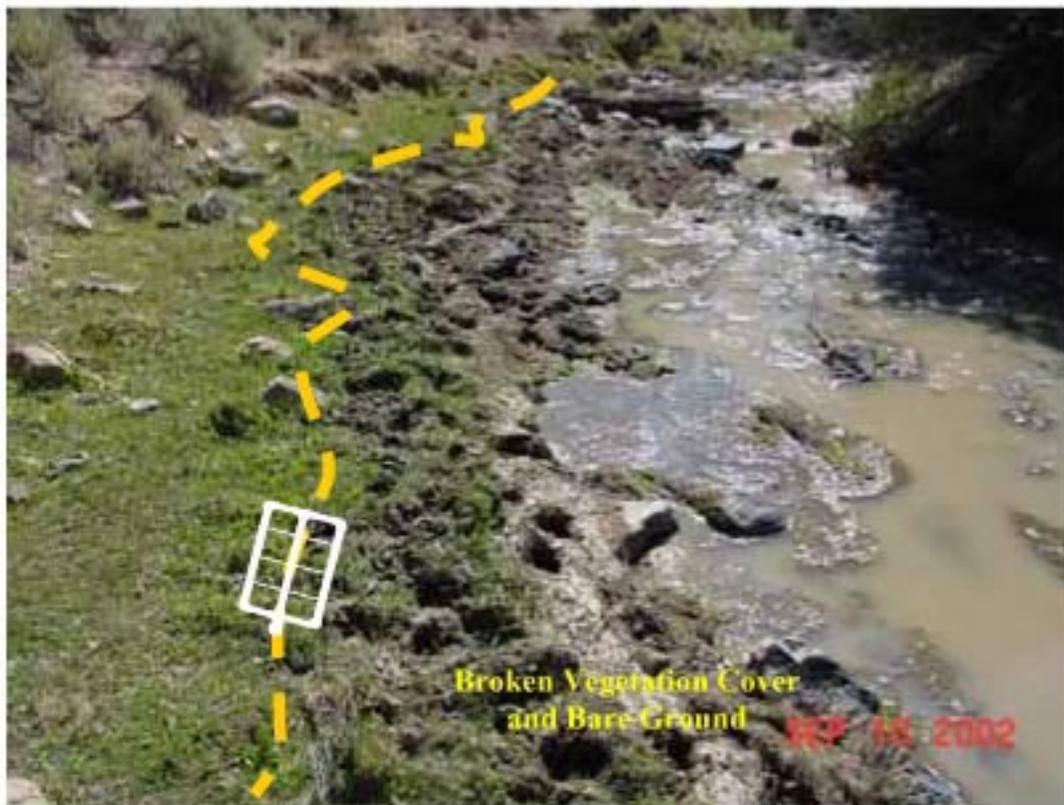
**Figure 1**—The greenline is along the orange dashed line. To the right of the dashed line is the relatively continuous stand of perennial vegetation (mostly Kentucky bluegrass). To the right of the dashed line is trampled bare ground and broken vegetation cover.

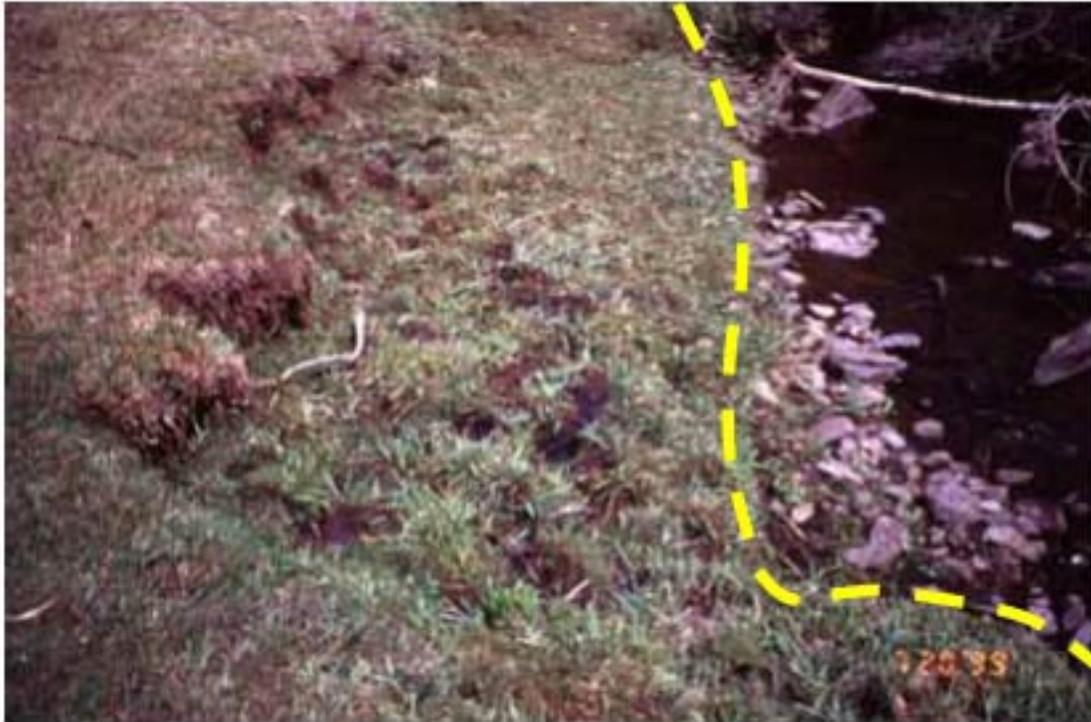
**Figure 2**—The greenline follows the dashed yellow line. The lineal grouping of perennial has over 50% vegetative cover.

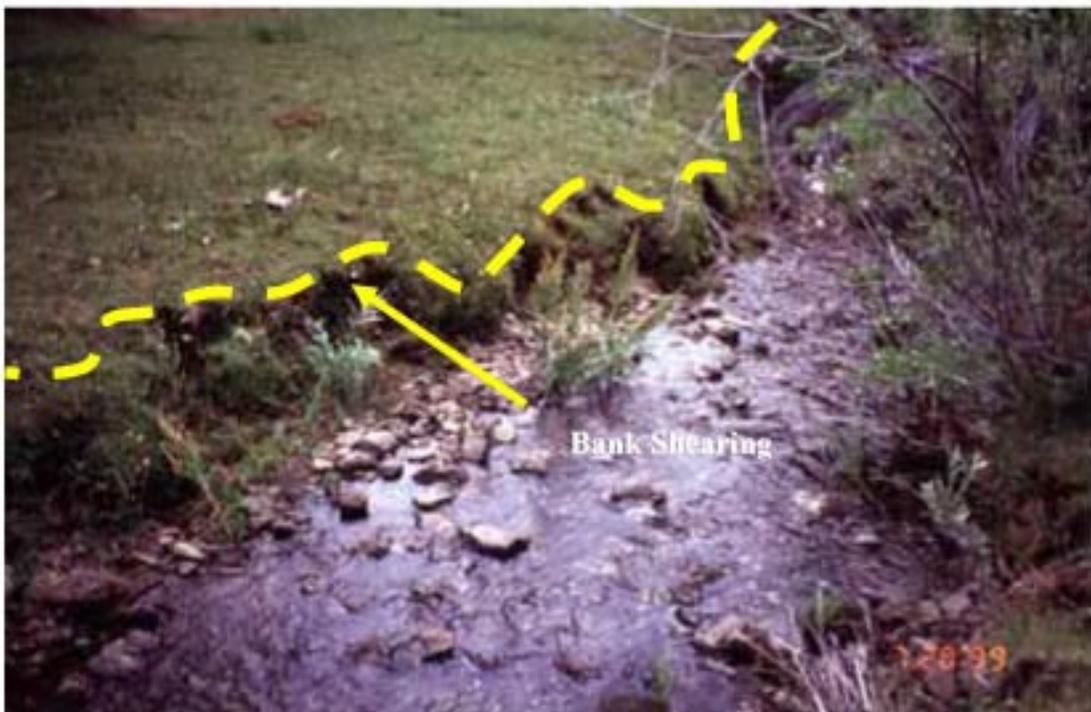
**Figure 3**—Greenline along an eroding streambank, shearing is evident.

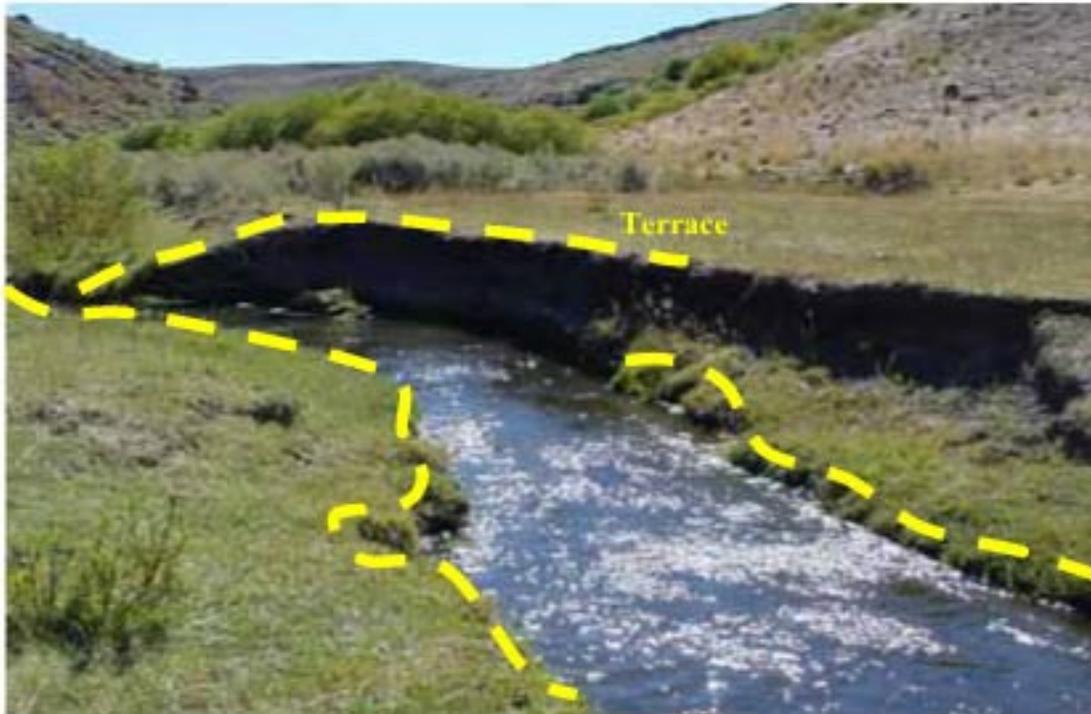
**Figure 4**—Livestock trampling top of the terrace (areas above the active floodplain) is not considered streambank alteration, except if livestock are trampling along the base of the streambank or shearing on the terrace wall. Stubble height measurements are not taken on the top of the terrace. Continue the transect until the hydric species are encountered.

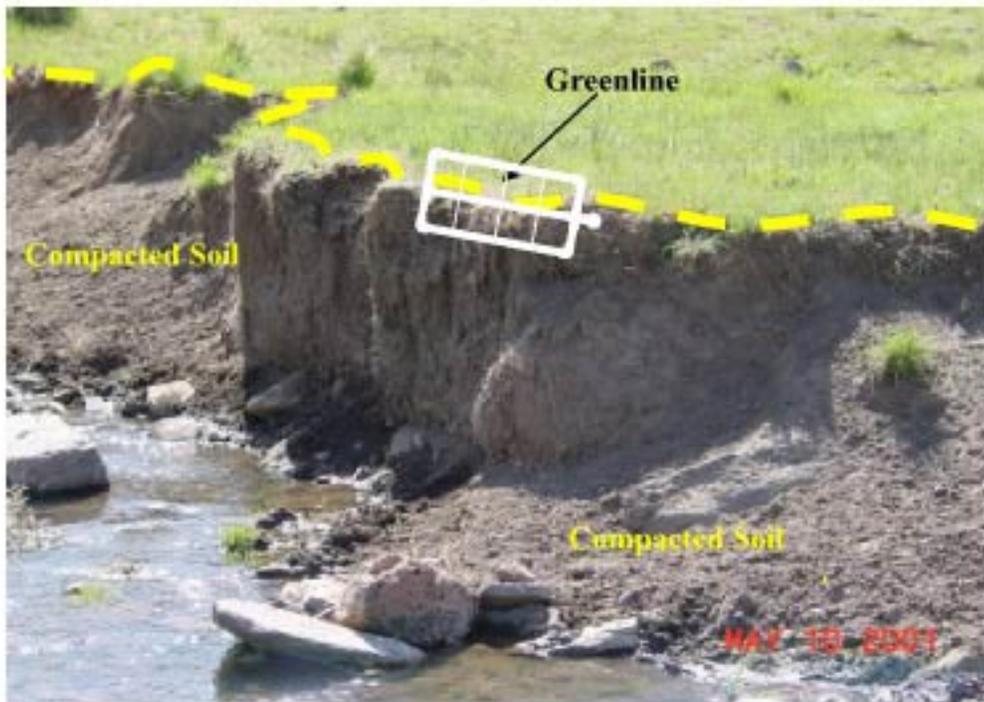
**Figure 5**—Trampling along the green line (dashed line). Note trampling along the base of the vertical terrace wall (arrows). Record as such.

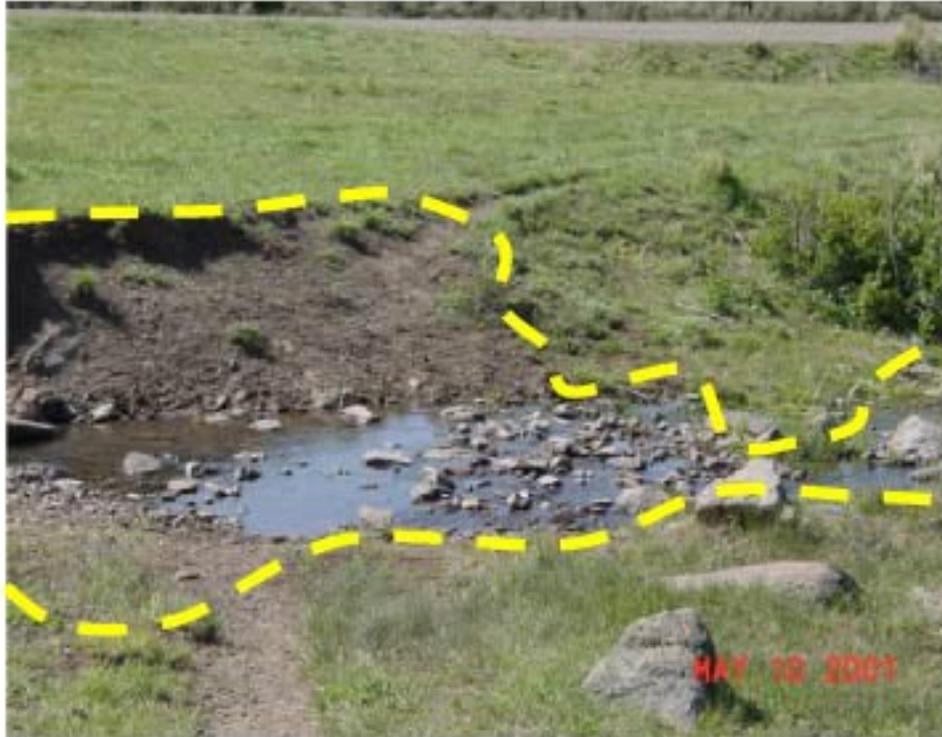
**Figure 6**—Livestock trail crossing the stream would be recorded as trampling even though the prints are less than  $\frac{1}{8}$  inch deep, due to compaction. Note the approximate bankfull line (dashed line).

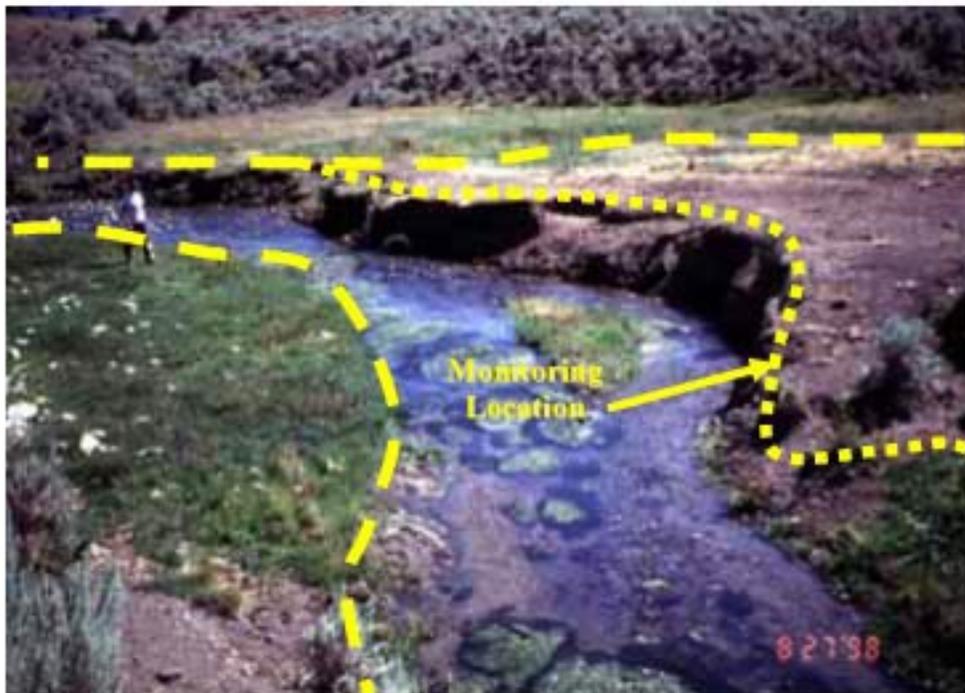
**Figure 7**—The greenline is located away from the streambank because only annual vegetation is located along the streambank. The fine dashed line shows the transect location.

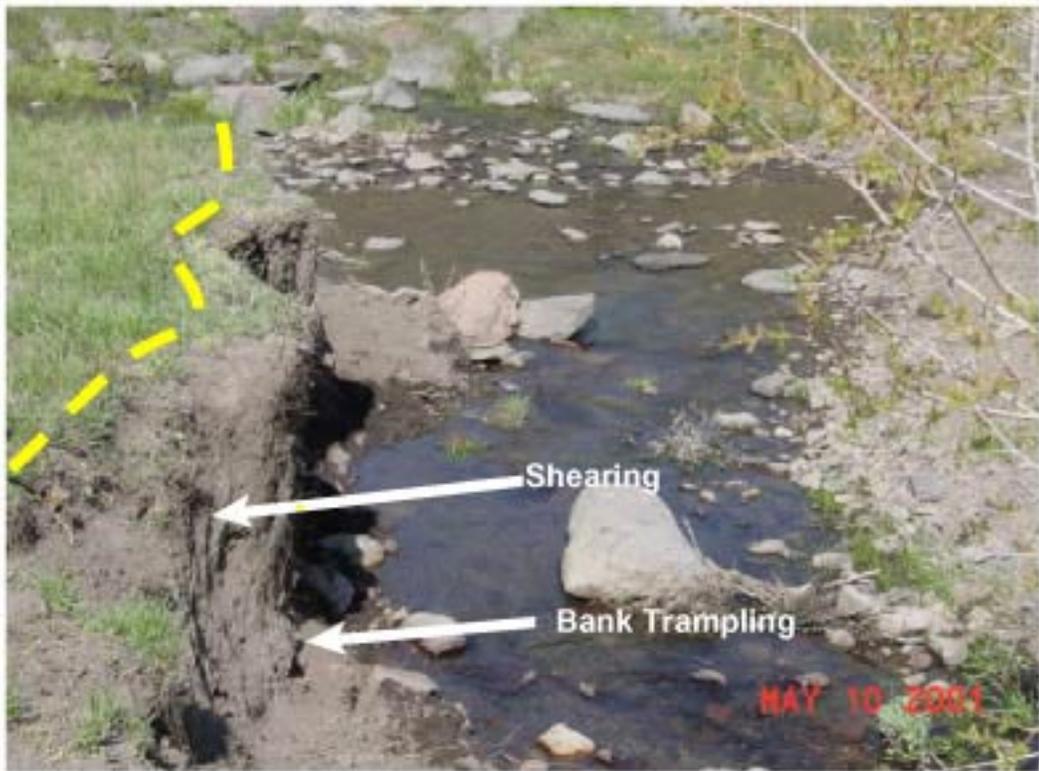
**Figure 8**--Shearing is along the terrace wall and bank trampling has occurred and is recorded as such.

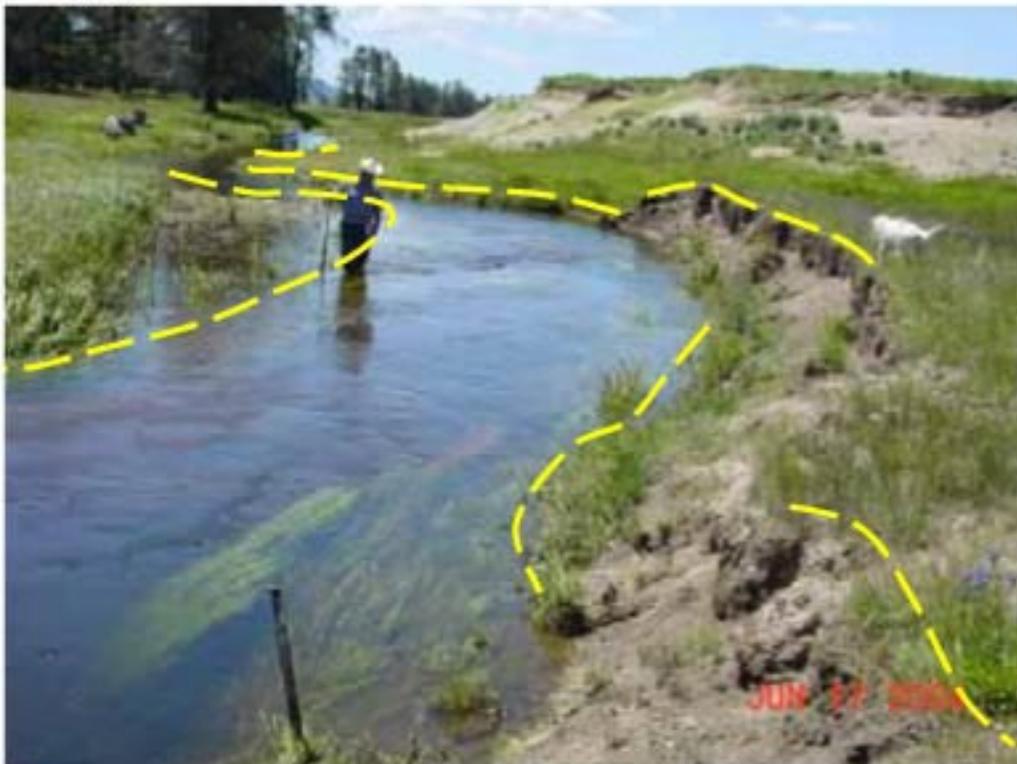
**Figure 9**—The greenline is below the water surface as the stream is above the base flow level. Note the greenline shifts from the terrace to the streambank where there is adequate vegetation

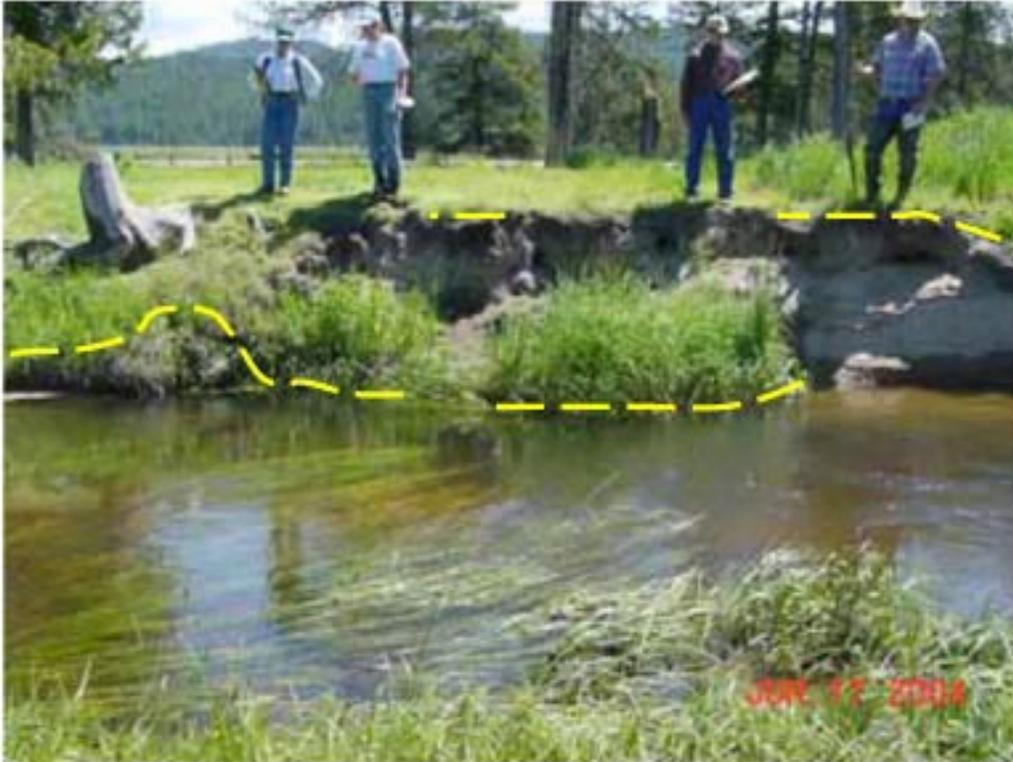
**Figure 10**—The water level is above bankfull, thus the greenline is in the water. Moving from right to left, the greenline follows the edge of the terrace until it reaches the vegetation along the water edge, it then shifts along the water's edge until it reaches the open area. It then shifts to back to the terrace, and then back to the water's edge.

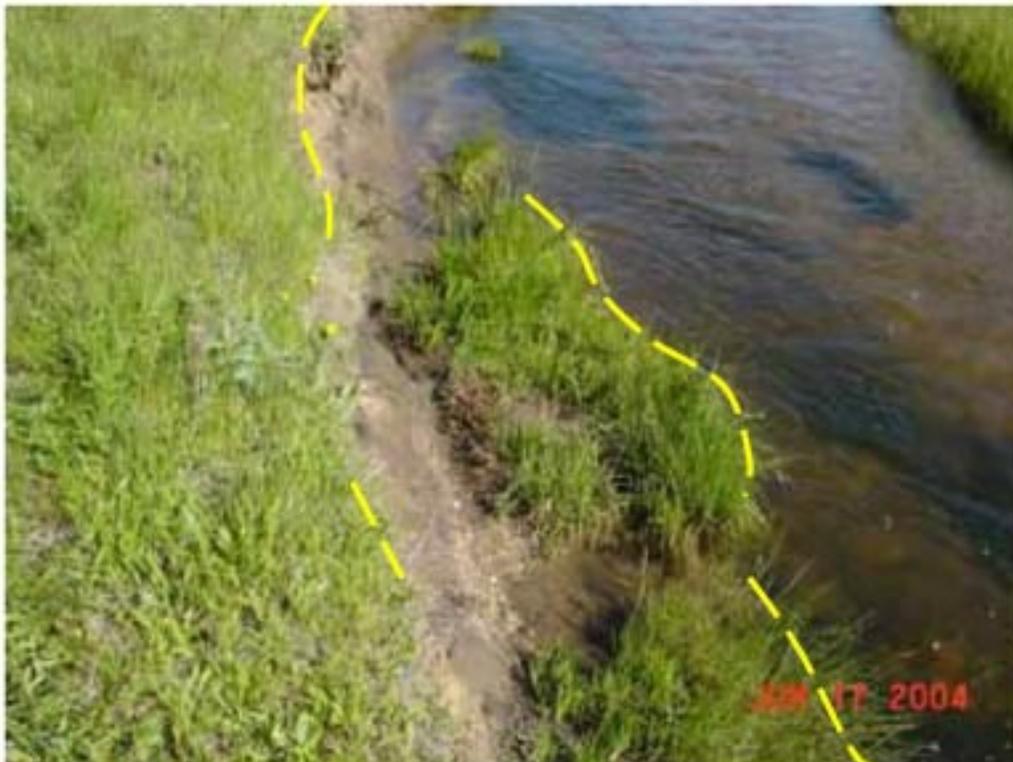
**Figure 11**—Vegetation along stream has more than 50% vegetation cover and area of at least 50% of the quadrant.

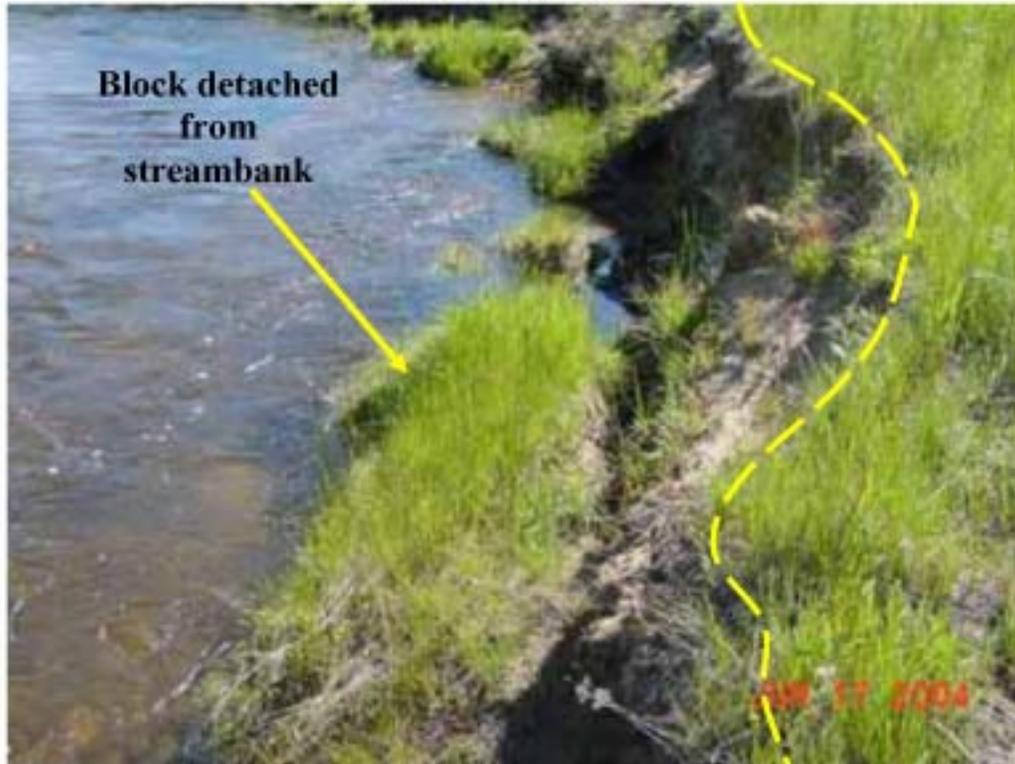
**Figure 12**—Slump block detached from the streambank. The greenline follows the line of perennial vegetation on the bank at the higher level.

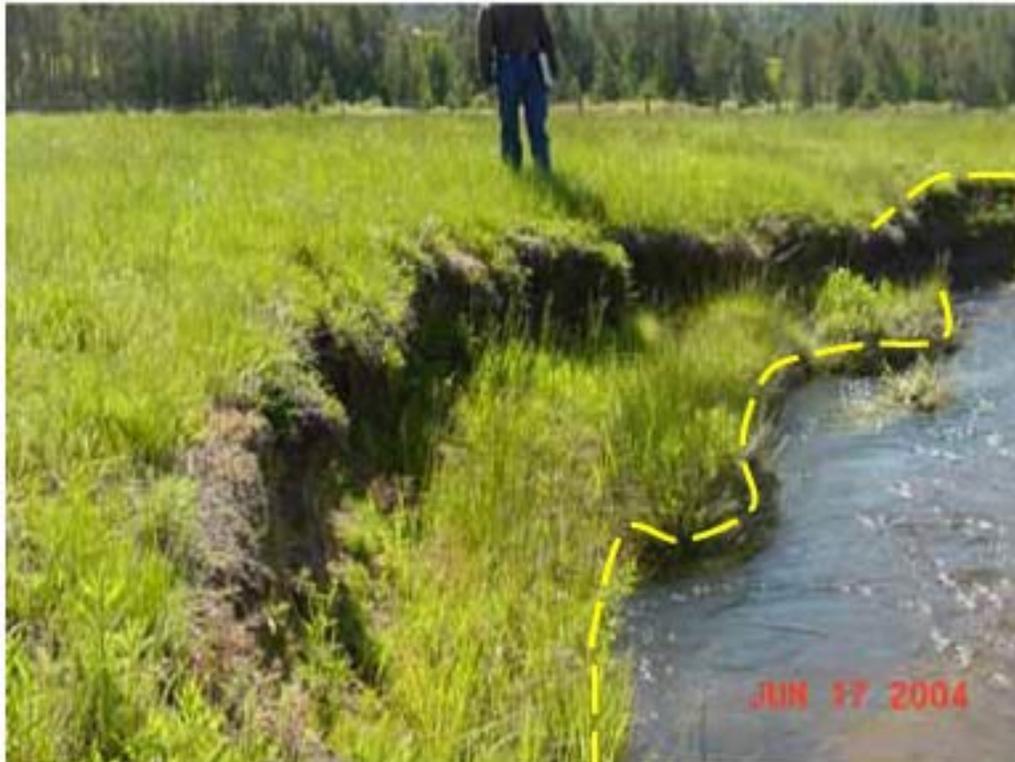
**Figure 13**—The slump feature is reattached to the streambank, thus the greenline is along the water's edge.

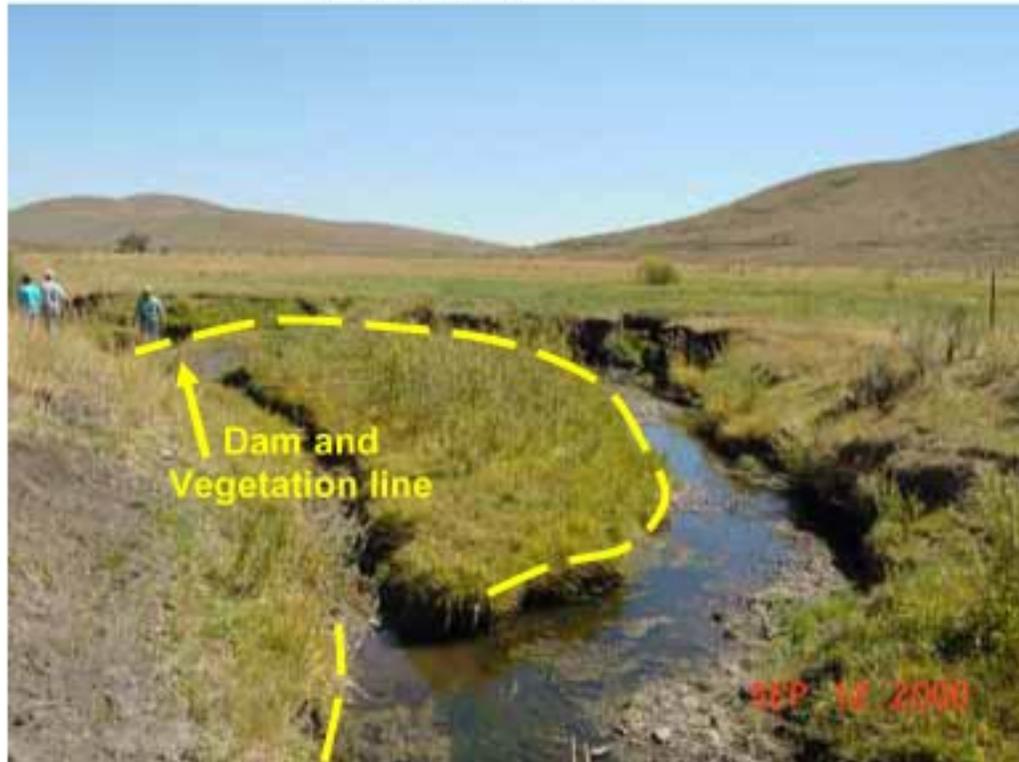
**Figure 14**—The greenline follows the vegetation line along the main channel because there is a dam and vegetation bridge at the lower end of the point bar. If an active channel continued creating an island, the greenline would follow the smaller channel and not on the island.

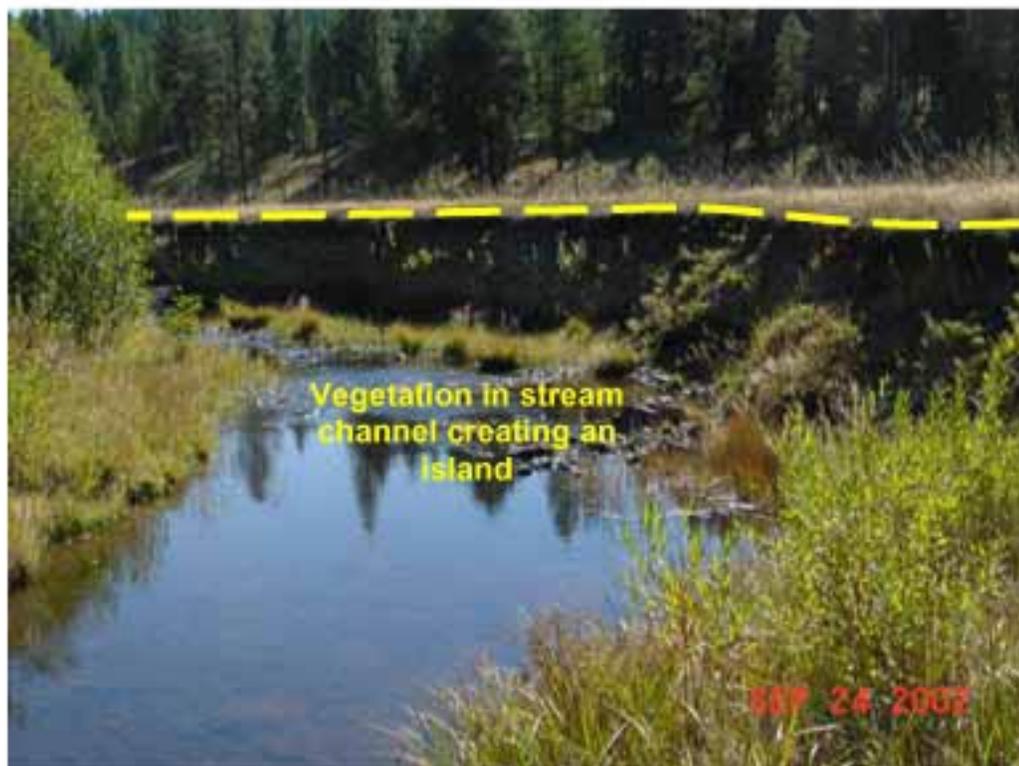
**Figure 15**—Vegetation in the stream channel is an island. The greenline remains at the edge of the terrace.

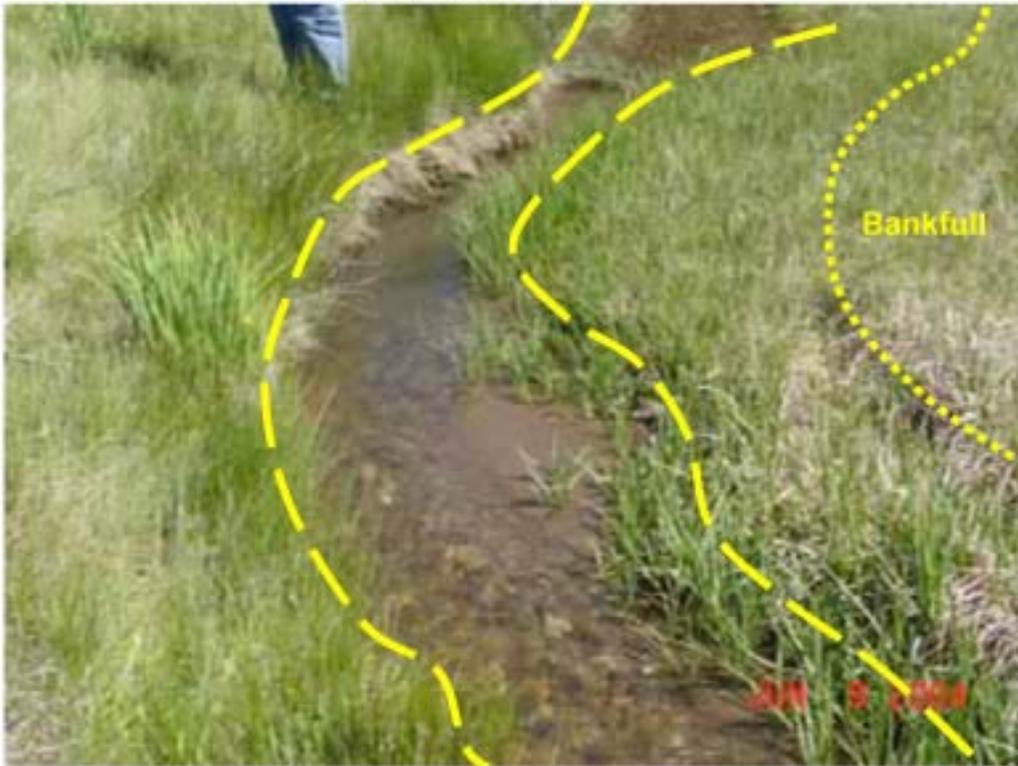
**Figure 16**—the greenline is near the water below bankfull narrowing the channel. The low water is a result of the drought conditions for past five years. Vegetation in the water is expanding from rhizomes and is less than 50% cover.
